# *The Cruck-Building at Corrimony, Inverness-shire*

GEOFFREY D. HAY

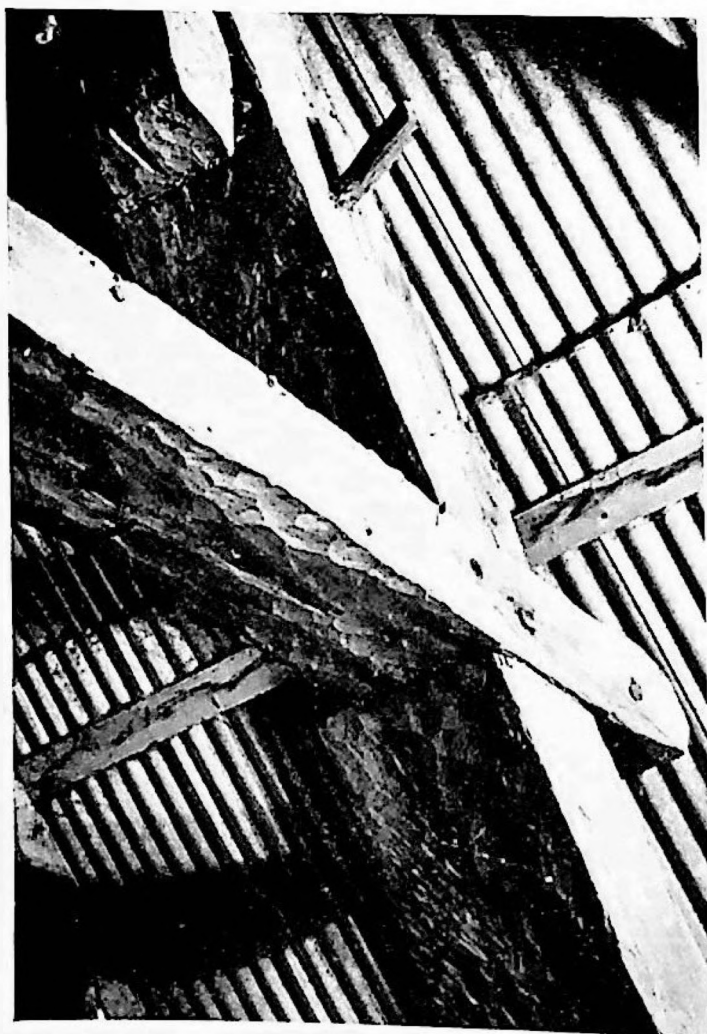
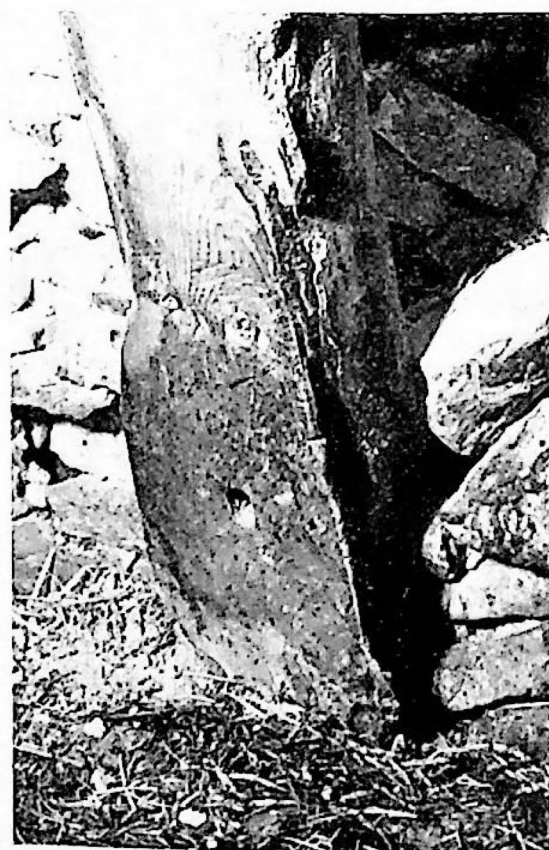
PLATE VII Cruck-building, Corrimony, Inverness-shire.

(above) cruck base and mortice-hole  
(NW blade, cruck v)  
(left) collar-joint and bracing peg  
(NW blade, cruck III)

The other important transverse member is the collar, the ends of which are extravagantly half-lapped through the blade sections thereby reducing the structural strength of both members by half. The ends project beyond the outer face of the crucks by about 16 inches to provide support for roof purlins. The flat rectangular section of the collars corresponds with that of the blades with which they are neatly jointed on the outer face. The joint between the two members is secured by a dowel-pin through the side and by another driven slant-wise through the back of the blade into the continuous portion of the collar. The projecting ends are neatly bevelled off, and the bearing surface is normally pierced with two peg-holes (but occasionally three or four) for the purpose of securing the horizontal members. A shallow notch cut in the backs of the blades 6 inches above the collars allowed a closer junction with the purlins which were probably of rectangular section. A dowel-hole of about  $1\frac{1}{8}$  inch diameter also occurs on the sides of each collar near the centre.

On the face of the cruck-blade on which the spur and collar-joints occur there is also a system of peg-holes, consistently spaced about 30 inches (measured along the cruck-blade) above and below the centre line of the collar. They do not penetrate right through the blade, and in general the drilling operation appears to have been preceded by indentations  $1\frac{1}{4}$  inch square by  $\frac{1}{8}$  inch deep cut with a chisel. If these holes are joined together diagonally from blade to blade, their intersection coincides approximately with the dowel-hole in the centre of the collar. The five points would therefore appear to be related and perhaps imply a system of superficial cross-bracing on this side of the blade.
